Manhole Inspection Summary

Manhole # S23AA1013MH

Insp Date: **1/29/07 2:40 PM**

Location Address: **1424 BERRY ST**

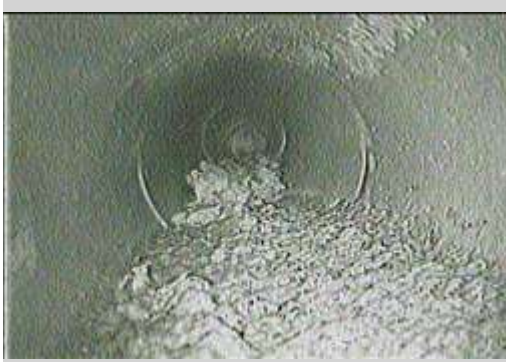
Inside the I6

Barrel infiltration. Evidence of surcharge - Bench debris. Channel debris. Corroded steps.

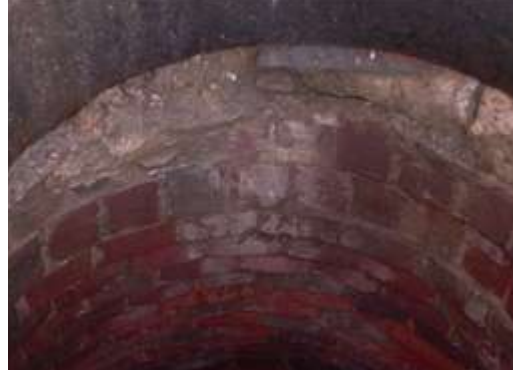
Defect

Frame Offset: **2** (in.) Condition: ☐ Sound ☐ Cracked ☒ **Leaks**

Condition: ☐ Sound ☐ Cracked ☐ Root Intrusion ☐ Loose Brick ☒ **Deteriorated**

Infiltration: ☐ None ☒ **Joint** ☐ Cracks ☒ **Mortar** ☐ Roots ☐ Wall

Frame leaks. Frame offset. Adjustment deterioration and infiltration.

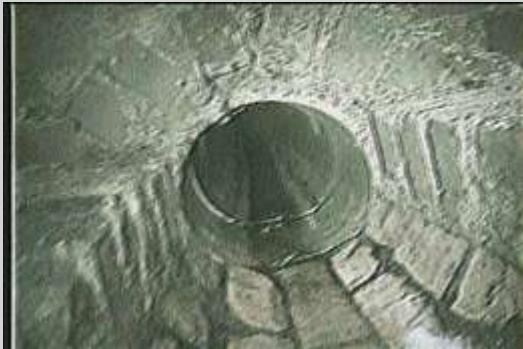
Pipe Out @ 12 O'Clock

8 in. Circular Gravity Sewer

Infiltration: **None** Pipe Seal Cond: **Cracked**

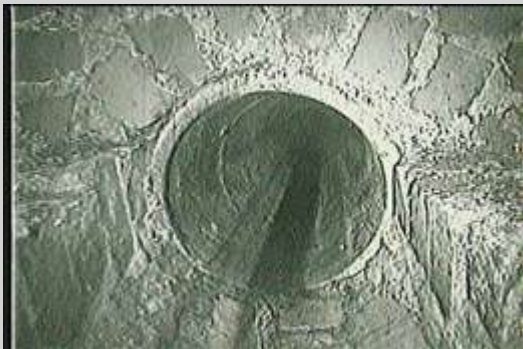
Pipe In @ 3 O'Clock

8 in. Circular Gravity Sewer

Infiltration: **Evidence** Pipe Seal Cond: **Unknown**

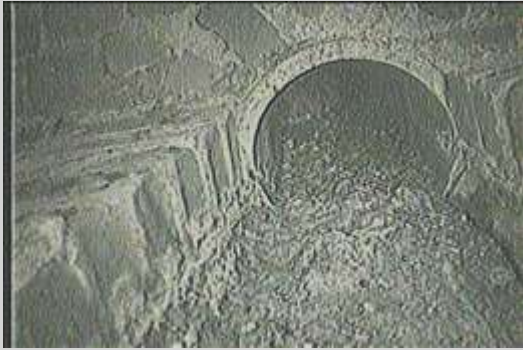
Pipe In @ 6 O'Clock

8 in. Circular Gravity Sewer

Deposits: ☐ None ☒ **Mud** ☐ Sludge ☒ **Debris** ☒ **Grease**

Silt Depth: **2** (in.)

Deposits Extent: **Medium**
